# Preventing Corrosion and Contamination in Samsung Scrubbers Systems with Siltride

## A SILCOTEK® CASE STUDY WITH:

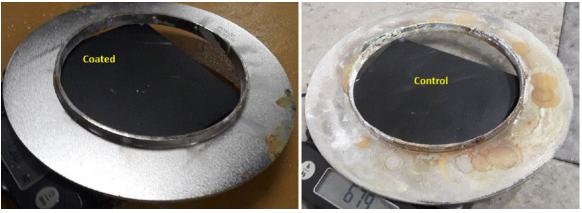
Figure 1: After 42 days in operation, the Siltride-coated (left) shows minor surface stains. The control sleeve shows major corrosion throughout.

The images in Figure 1 (below) were taken after the parts had been in use for 42 days. Corrosion and degradation is evident all over the uncoated quenching sleeve, whereas the coated component shows only some minor stains. Additionally, the Siltride-coated parts measures with no mass loss and the control (uncoated) lost 10% of its mass after 42 days in operation.

After 42 days in operation, the Siltride-coated (left) shows minor surface stains with no mass loss and the control sleeve shows major corrosion throughout as well as a 10% loss in mass.
